Manhole Inspection Summary

Manhole # S53K__045MH

Insp Date: **7/30/08 8:38 AM**

Location Address: **rear off 3308 schuck**

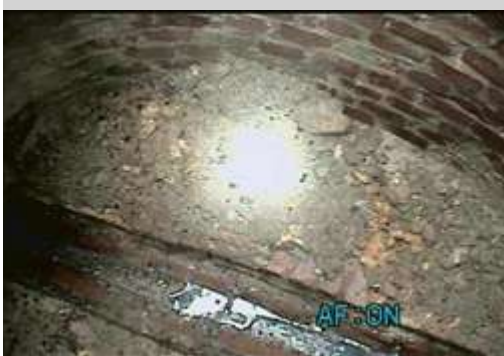
Defect 3

Condition: ☐ Sound ☐ Cracked ☐ Root Intrusion ☐ Deteriorated ☐ Leaks ☒ **Debris**

bench debris

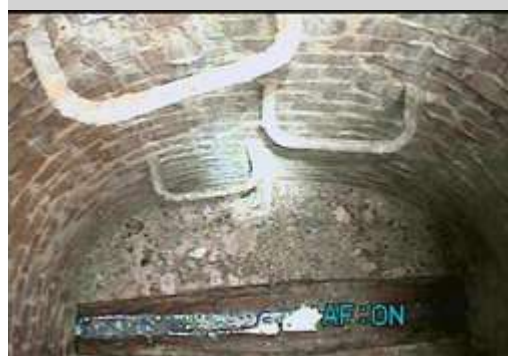
Defect 2

Steps Count: **3** Missing: **0** ☒ **Corroded**

steps

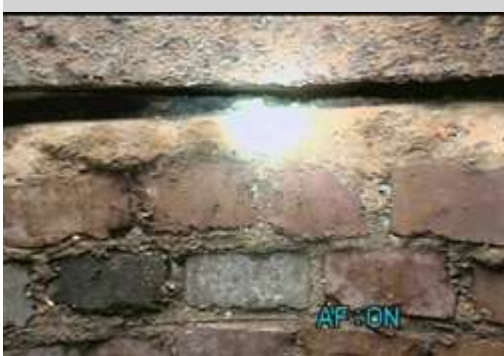
Defect 1

Chimney / Frame Adjustment ☒ Exists Material: **Brick** ☐ Parged Height: **3** (in.)

Condition: ☐ Sound ☐ Cracked ☐ Root Intrusion ☐ Loose Brick ☒ **Deteriorated**

deteriorated, frame adjustment

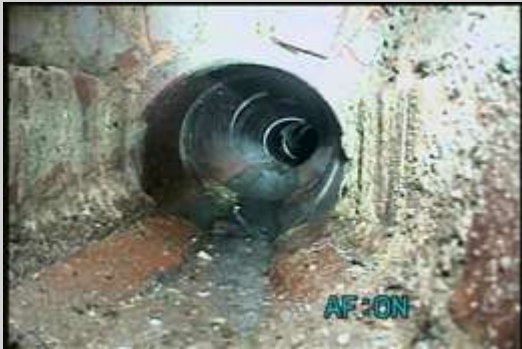
12 O'Clock Outflow

8 in. Circular Gravity Sewer
Pipe Out @ 12 O'Clock

Pipe Material: **Clay** ☐ Pipe Lined

Invert Depth: **7.16** (ft.) Flow Characteristics: **None**

Deposits: ☒ None ☐ Mud ☐ Sludge ☐ Debris ☐ Grease

Infiltration: **None** Pipe Seal Cond: **Sound**

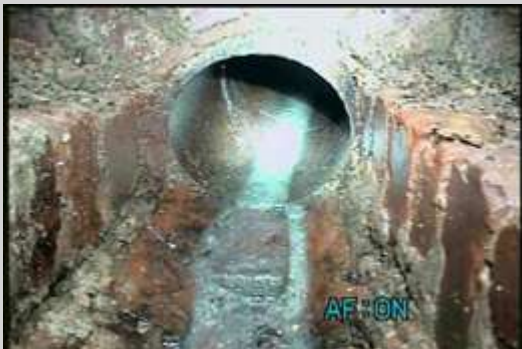
6 O'Clock Inflow

8 in. Circular Gravity Sewer
Pipe In @ 6 O'Clock

Pipe Material: **Clay** ☐ Pipe Lined

Invert Depth: **7.00** (ft.) Flow Characteristics: **None**

Deposits: ☒ None ☐ Mud ☐ Sludge ☐ Debris ☐ Grease

Infiltration: **None** Pipe Seal Cond: **Sound**
